**MARYLAND HISTORICAL TRUST  
DETERMINATION OF ELIGIBILITY FORM**

Property Name: Staley-Summers House Property Inventory Number: F-2-110  
Address: U.S. 340 U.S. Route 340, Jefferson Pike Historic district: ☐ yes ☒ no  
City: Petersville Zip Code: 21716 County: Frederick  
USGS Quadrangle(s): Point of Rocks  
Property Owner: Maryland State Highway Administration Tax Account ID Number: N/A  
Tax Map Parcel Number(s): 32 Tax Map Number: 83  
Project: Staley-Summers Architectural Inventory Agency: Maryland State Highway Administration  
Agency Prepared By: A.D. Marble & Company  
Preparer's Name: Stephanie Foell Date Prepared: 12/28/2004  
Documentation is presented in: Companion MIHP form of the Staley-Summers Architectural Inventory  
Preparer's Eligibility Recommendation: ☐ Eligibility recommended ☒ Eligibility not recommended  
Criteria: ☐ A ☐ B ☐ C ☐ D Considerations: ☐ A ☐ B ☐ C ☐ D ☐ E ☐ F ☐ G  
*Complete if the property is a contributing or non-contributing resource to a NR district/property:*

## Maryland Inventory of Historic Properties Form

Staley-Summers House Property

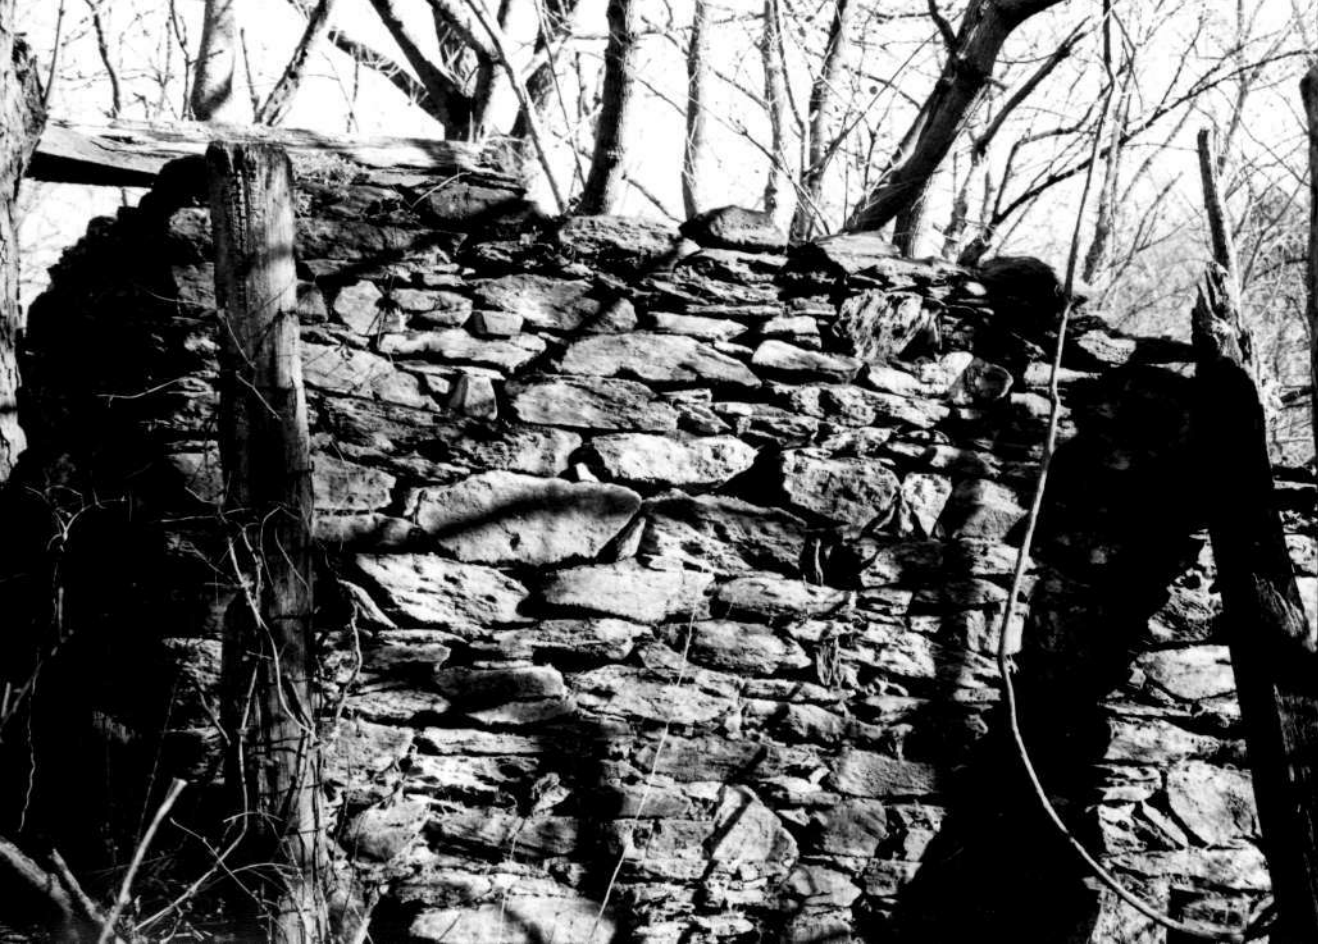
17/23

The field-stone and cinder-block foundation is all that remains of the bank barn, which is located to the southwest of the log house. It appears that the cinder blocks were used to enclose the original overhanging forebay (photos on file at SHA, file No. 45824). A poured-concrete trough is located on the ground in the center of the barn. It was once used to keep the interior of the barn free of livestock excrement, as it functioned as a waste receptacle. The trough was easy to maintain by simply hosing the waste matter out the trough. Currently, the foundation is collapsed in sections and heavily overgrown with trees, the superstructure is gone; therefore, the barn no longer conveys its original association with the farmstead.

Remnants of bank barn foundation;  
view to the west

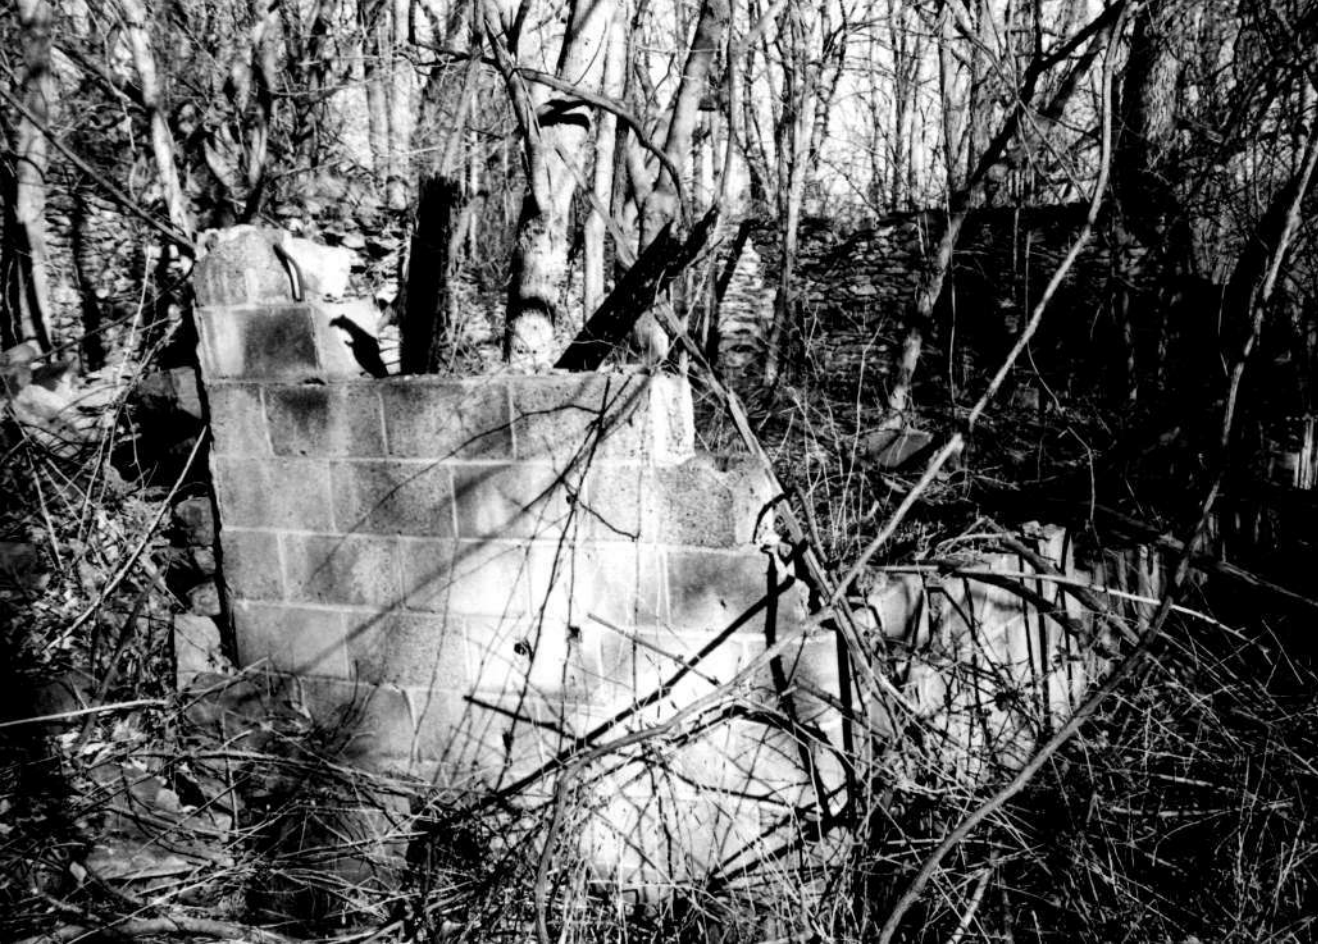
18/23

Remnants of bank barn  
foundation, view to the NE

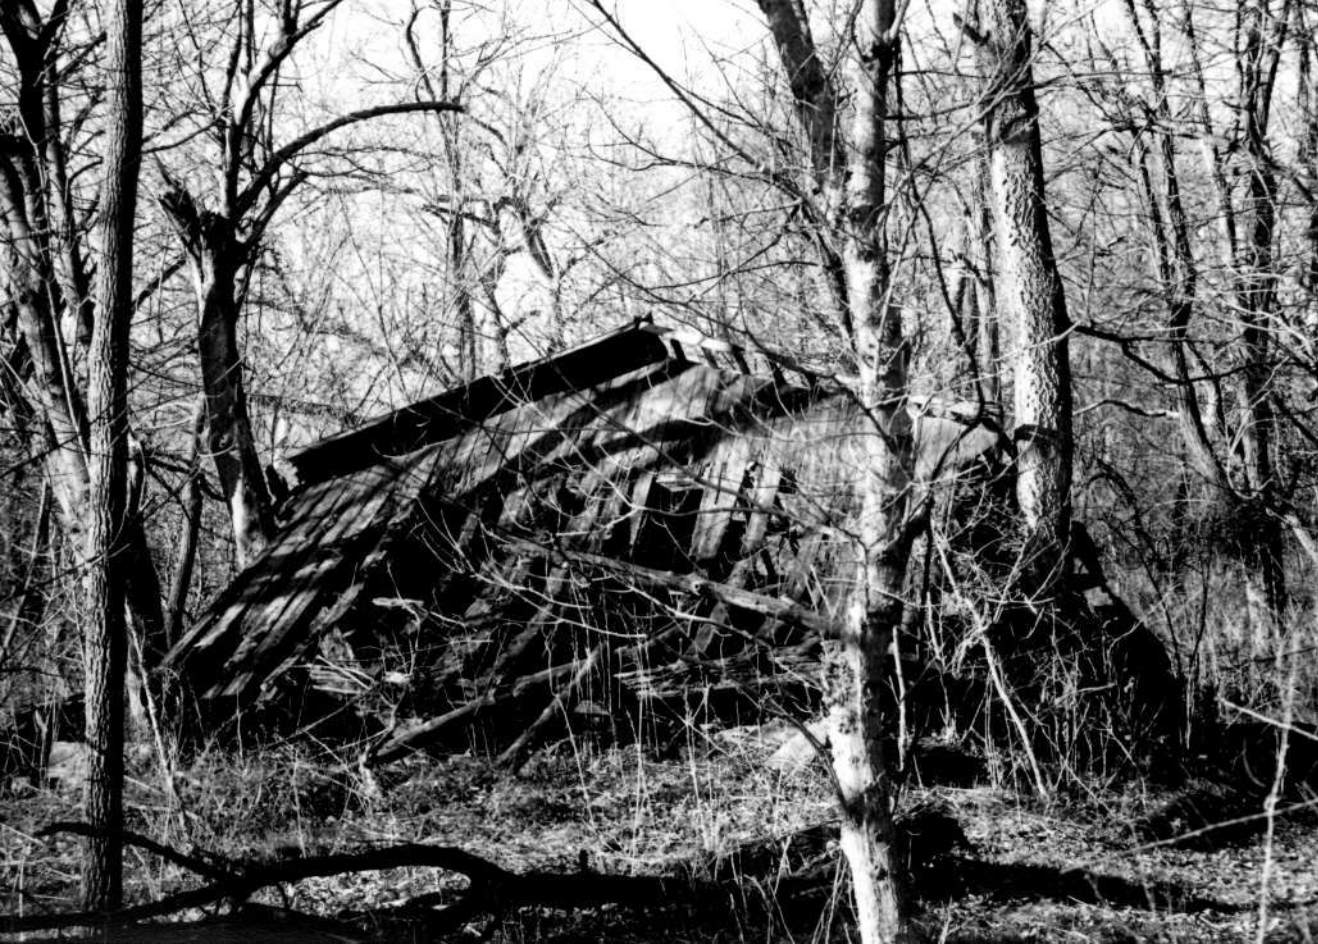
19/23

An additional collapsed agricultural outbuilding is present on the site. The wood-frame building had a stone foundation and was topped with a metal roof. The footprint of the possible springhouse (or icehouse) on the Staley-Summers parcel is symmetrical, with the gable ends oriented along a north-south axis. The visibility within the interior is poor, due to the collapsed superstructure covering the majority of the interior. Presently, the remains of a corrugated tin roof cover the wood rafters of the west side of the collapsed outbuilding. This ancillary outbuilding no longer conveys its original appearance and function on the farmstead.

The Staley-Summers springhouse is located about 30 feet to the east of an unnamed tributary of the Catoctin Creek. The collapsed superstructure is constructed of red-painted timber, and the foundation shaft is lined with field stones. A poured concrete enclosure is situated about six feet to the west of the probable springhouse entrance; poured concrete also covers the exterior of the stone foundation. The small enclosure has a narrow opening in the west wall, which is close to the stream below the hill slope. Most likely, repeated flooding in the area has silted over the original springhouse water channel, as a slight, narrow depression in the earth is visible from the west wall of the springhouse leading down to the stream.

View of collapsed springhouse;  
view to the northwest

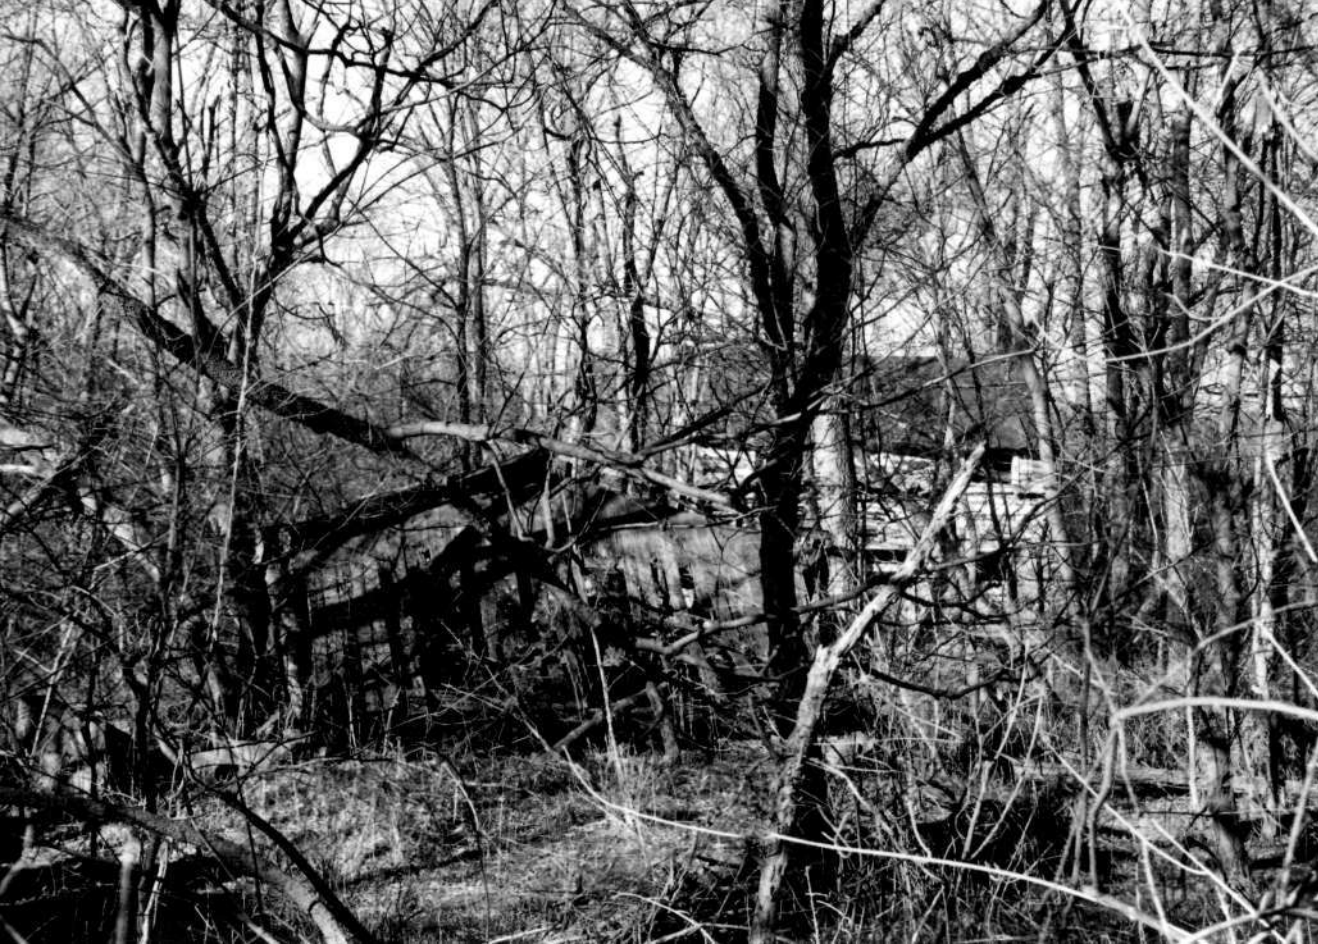
20/23

View of collapsed springhouse in  
foreground and log house in  
background, view to the north

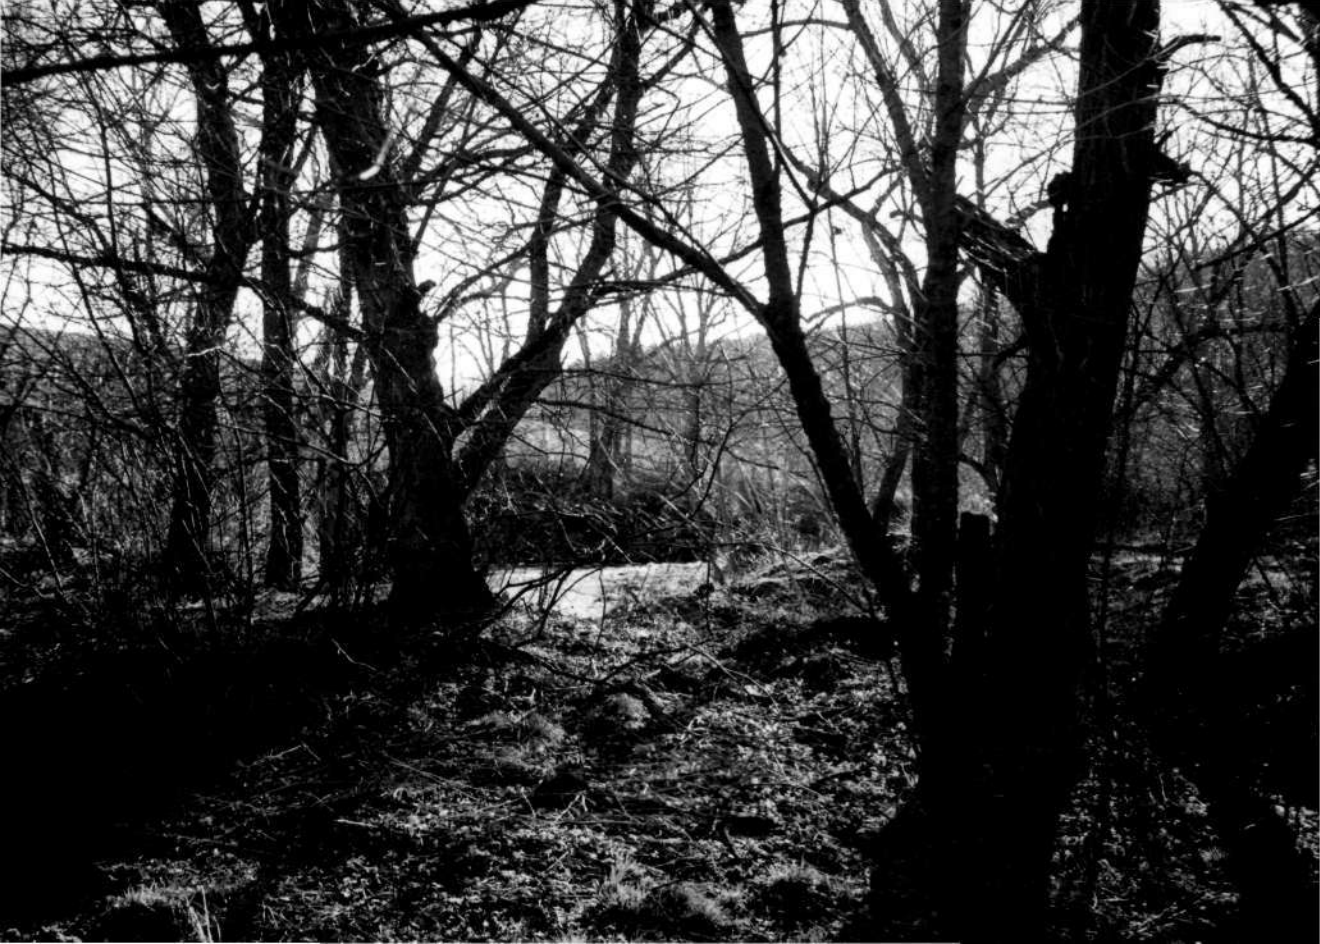
22/23

The landscape of the Staley-Summers House property is entirely overgrown and retains few features of the former agricultural and cultural landscape. A well identified in a 1993 survey (see Payne) could not be located during the most recent architectural survey. The trace of a nineteenth-century road runs parallel to Catoctin Creek, located at the southern boundary of the property. A worn path, recently cut in by local hunters, is found along the southern portion of the property, but much closer to the farmstead complex. This path winds around and approaches the log house on the western perimeter. The farmstead complex is largely overgrown in brambles and stands of young deciduous trees. A large, mature, deciduous tree is located to the east of the house. There are no remnants of ornamental plantings within the farmstead complex. Osage-orange fruit was found within the Staley-Summers House property parcel during the architectural survey. While this was commonly used for hedgerows, no discernable patterns remain. Small sections of woven-wire fencing are located near the house and outbuildings. South of the log house, a woven-wire fence gate and fence are still extant, as well as a small remnant of wire fence found in a grove of trees near the stream confluence.

View of property, including  
Catoctin Creek; view to the SW

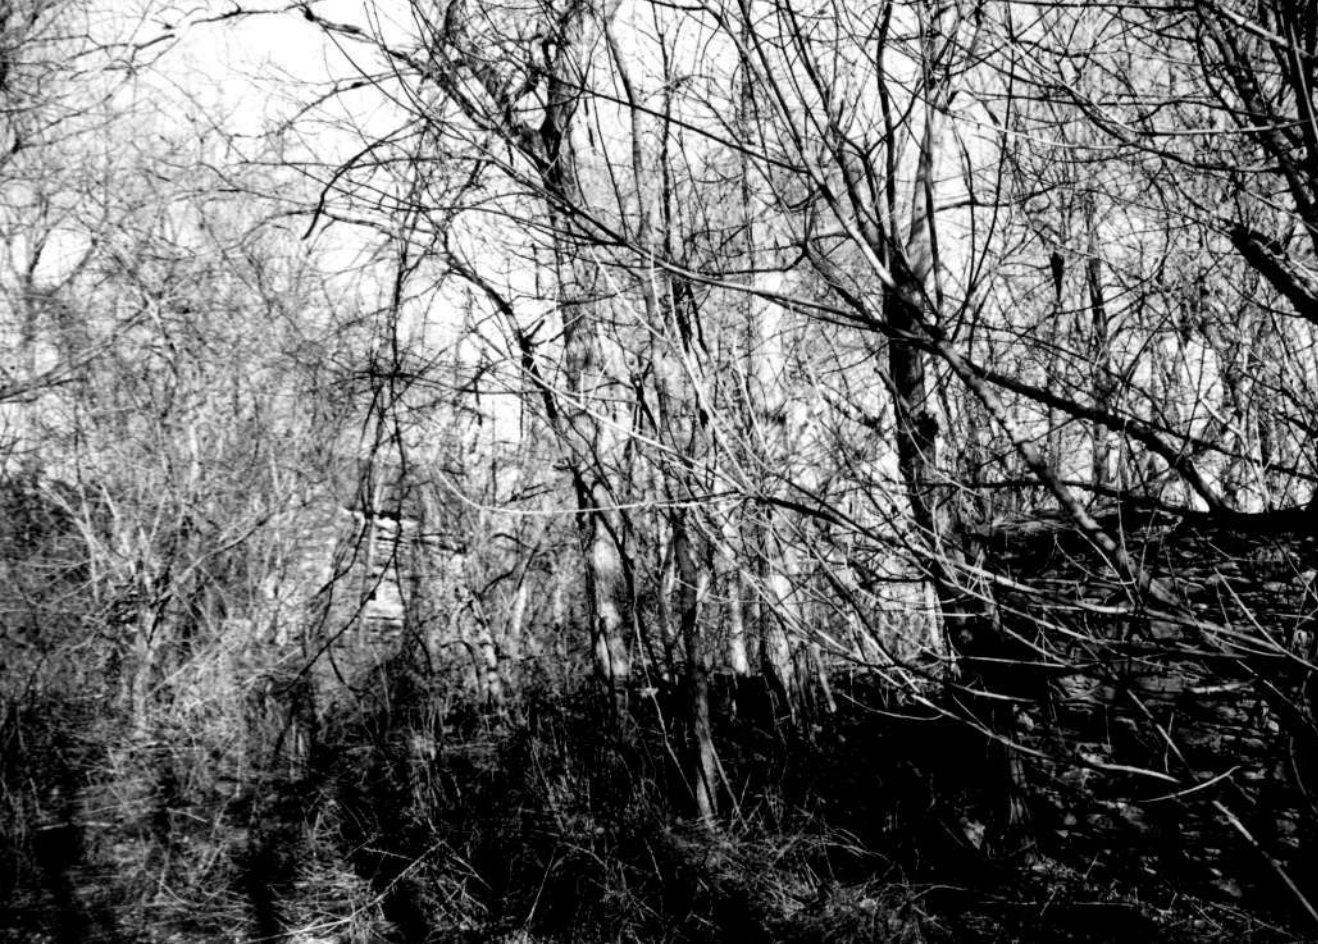
No discernable remnants of agricultural land use remain. No field patterns, pastures, orchards, gardens, or other typical agricultural land-use patterns remain. The property is heavily wooded and contains primarily new-growth deciduous trees and invasive ground cover.

Overview of property with  
bank barn foundation in foreground  
and log house in background, view  
to the NE
